PROPERTY LOCATION: Inspection Address City KY Zip

# **INSPECTION REPORT** PREPARED FOR: Client's Name

Date of Inspection 8/25/2020

**Inspector: Joshua Adkins**

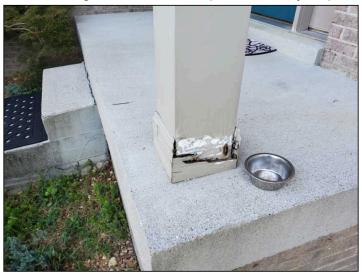
2.2. Advanced wood decay was visible at a porch post that supports the porch covering. Recommend replacement by a qualified person.

Wood decay - Front porch post

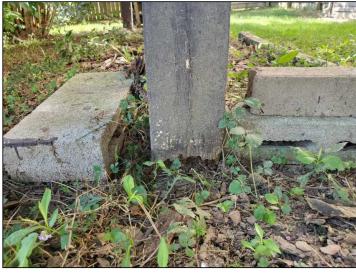
6.1. Two deck posts had decay from contact with soil. Recommend repair by a qualified person to maintain safe conditions.

Wood deterioration

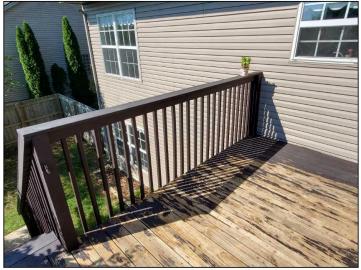
6.2. Guardrails were very loose due to the posts being secured to the deck using nails. Recommend installing bolts to better secure the posts for safety.

Loose guardrail

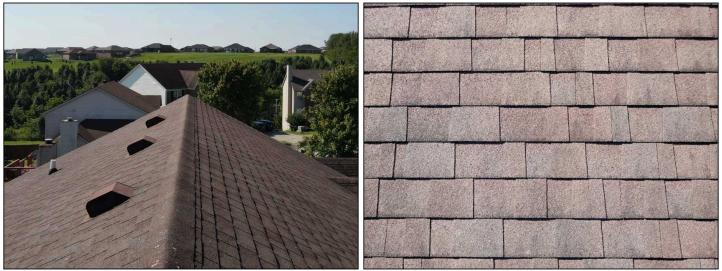
**Ridgeline View**

**Closeup View**

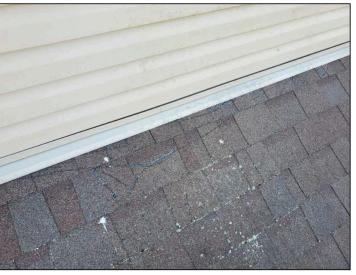
3.1. There was a damaged shingle observed on the roof. Moisture intrusion could damage the roof decking below. Recommend repair/replacement by a qualified person.

Damaged shingle - Left side of home

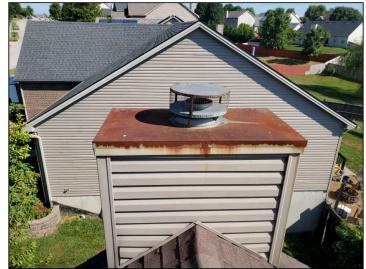
5.1. The sheet metal chimney chase cover exhibited moderate corrosion. Recommend prepping and painting to extend the lifespan of the cover.

Corrosion

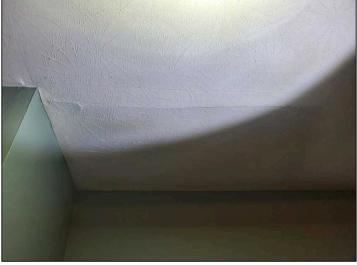
3.1. There were areas with loose drywall tape. While there can be different reasons for this, the most common are poor application technique and normal settling in new construction.

Loose tape - Master bedroom

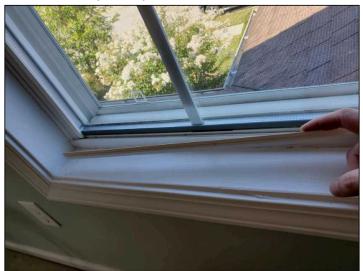
7.1. The vinyl lift rail was damaged at a window sash in an upstairs bedroom. Recommend repair/replacement.

Bottom sash trim damaged - Upstairs bedroom

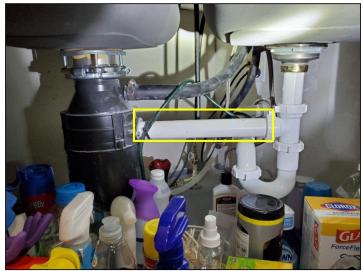
10.1. The drain pipe for the disposal was improperly sloped causing water to spray out of the sink and onto the floor when the disposal was turned on. Recommend correction by a qualified person.

Pipe improperly sloped

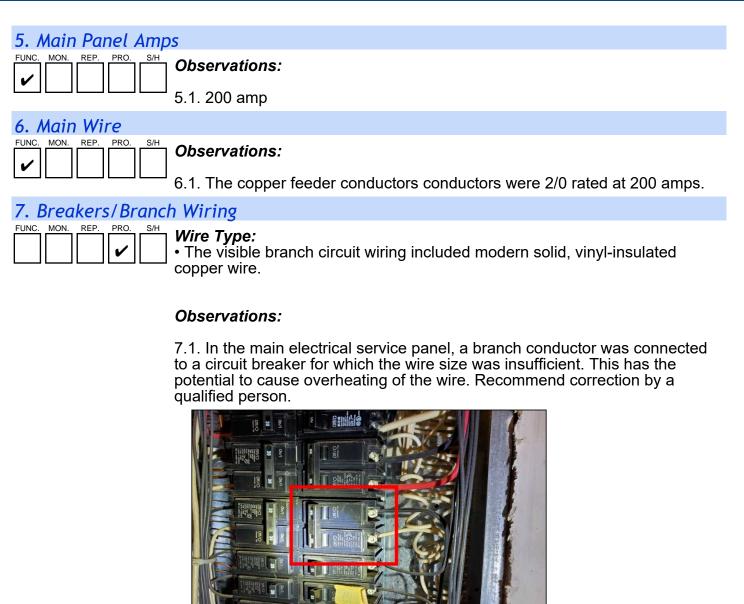
Oversized breaker

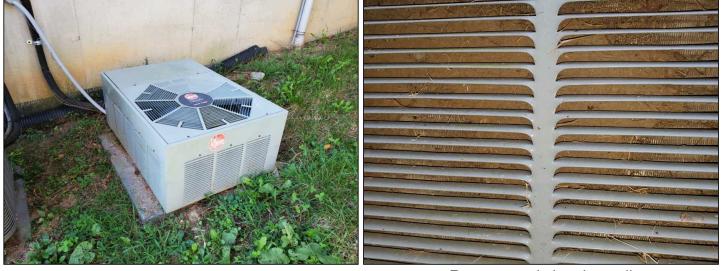
7.1. Airflow to the air-conditioner condenser coils was restricted by dirt and/or debris on the exterior which may limit the system ability to dissipate heat. Recommend cleaning the coil as part of your regular maintenance. This can be accomplished by using a water hose to spray the dirt away.

Recommend cleaning coil
