PROPERTY LOCATION: Inspection Address City KY Zip

INSPECTION REPORT PREPARED FOR: Client's Name

Date of Inspection 10/6/2019

Inspector: Joshua Adkins

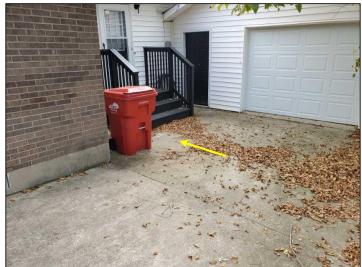
2.1. Perimeter pavement appears to slope towards building. Recommend taking measures to direct rainwater away from the foundation.

Negative grade

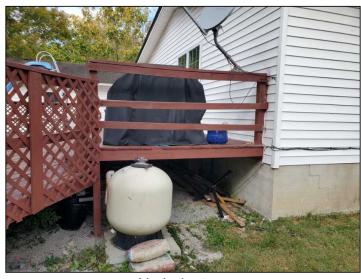
6.1. A guardrail did not have balusters installed. Safe building practices dictate that a 4 3/8-inch sphere may not pass through the guardrail at any point. This condition may be hazardous to small children. Recommend repair. FHA/VA

No balusters

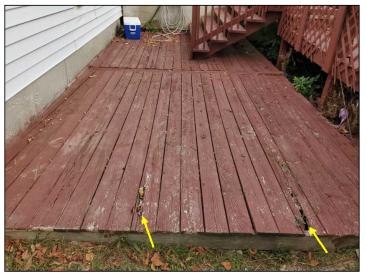
6.2. Several deck boards were deteriorated and floor joists were not secured to a rim joist causing unsafe conditions. Recommend evaluation and repair/replacement by a qualified person for safety. FHA/VA

Deck boards deteriorated

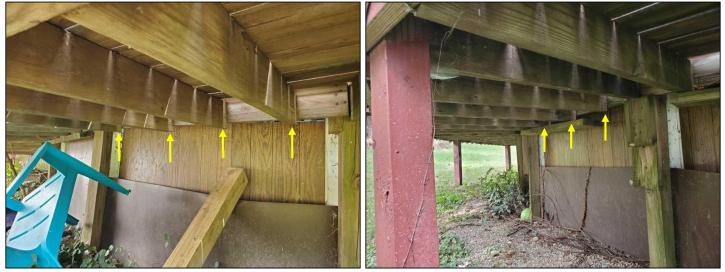
Floor joists not secured to rim joist

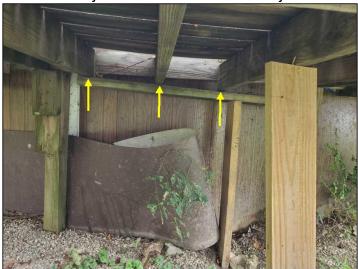
Floor joists not secured to rim joist

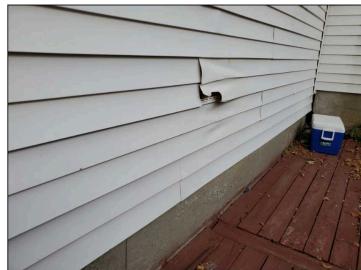
2.1. The vinyl siding had one or more areas of damaged siding that should be sealed or replaced to prevent moisture intrusion.

Damaged siding - Detached garage

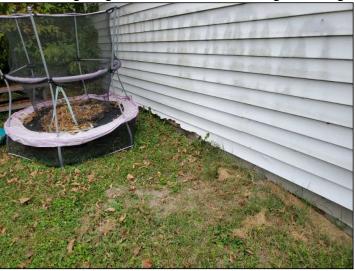
Damaged siding - Detached garage

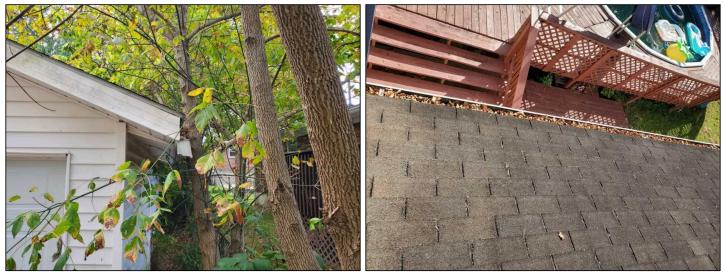
6.2. Gutters were damaged at the right side of the garage and may result in rainwater discharging at the foundation. This condition can result in damage related to soil/foundation movement. Recommend repair.

Damaged gutters - Detached garage

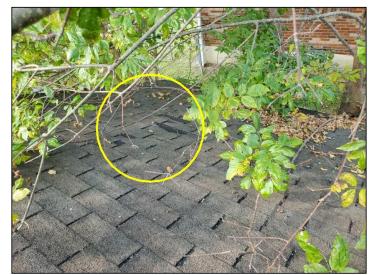
3.1. There were several damaged shingles observed on the garage roof and moisture damage visible at the roof decking below (See garage section for more information). Recommend evaluation and repair/replacement by a qualified person to prevent further damage.

Damaged shingles - Detached garage

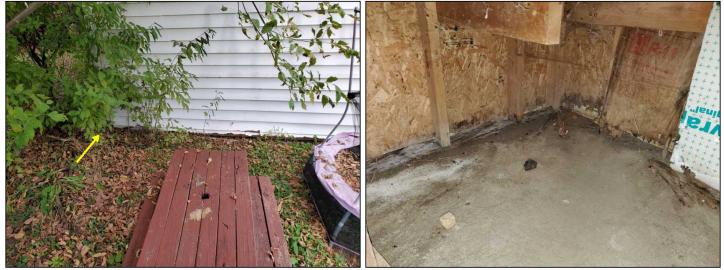
1.1. The wall structure had areas with severe wood deterioration due to the soil grade being too high causing moisture intrusion of the wall structure. Recommend evaluation and repair/replacement by a qualified person to ensure that the structural integrity is sound.

Wall below grade

Moisture damage - Detached garage

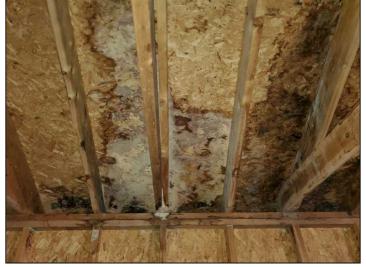
2.1. Moisture damage in the roof decking appeared to be the result of recent moisture intrusion due to defects found at the shingles. See roof section for more information.

Moisture damage - Detached garage

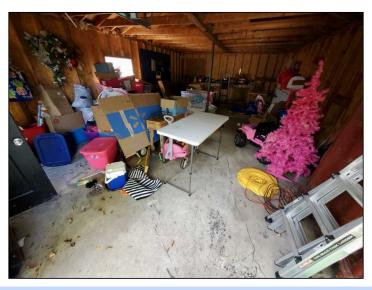
2.2. A jack post was not properly secured to a support beam. Recommend correction to ensure that the beam and roof structure is properly supported.

Post not properly secured to a support beam

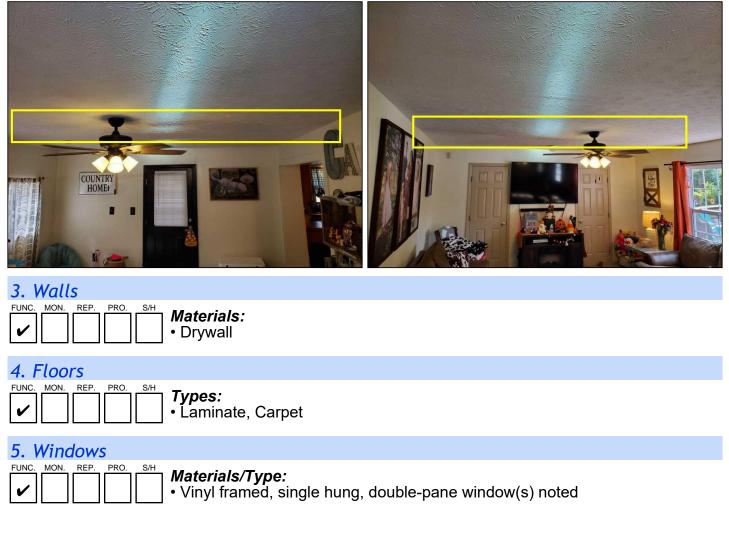
2.1. The ceiling had visible sagging. This condition was due to defects found in the roof structure. See attic section for more details.

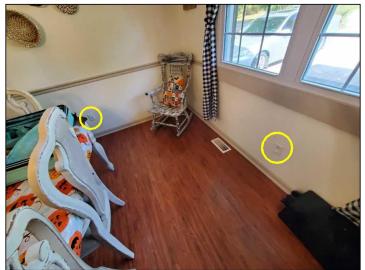
6.1. One or more electrical receptacles were inoperable at the time of the inspection. Recommend evaluation and correction by a qualified contractor.

Electrical receptacles not functional - Dining room

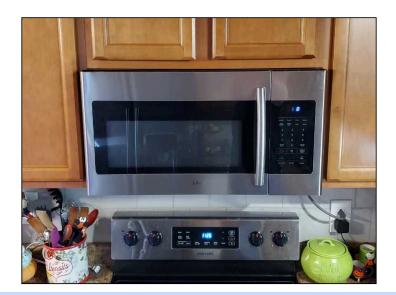
7.1. A light fixture did not respond to the switch at the time of the inspection. Recommend evaluation and repair by a qualified person.

Light not functional

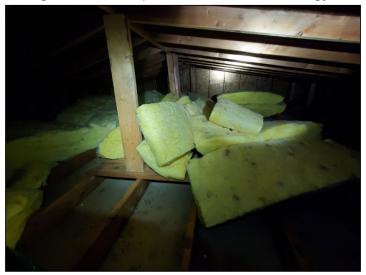
3.1. Fiberglass batt insulation was located in the attic space above the addition of the home but was not in contact with the drywall. Recommend securing insulation in place for increased energy efficiency.

Insulation not in contact with drywall

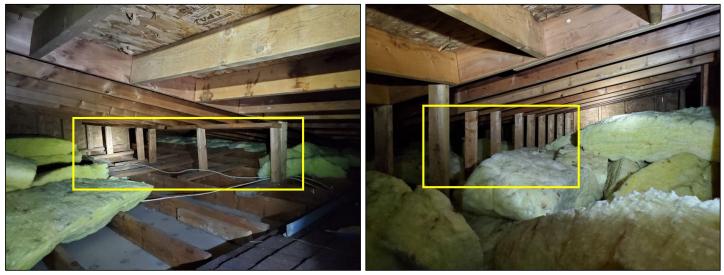
4.1. Bracing of the purlin system designed to support rafters was installed in a manner that transferred the roof load to ceiling joists. This condition has caused ceiling joists to sag. Sagging will likely worsen over time unless steps are taken to correct this condition. Recommend evaluation and repair by a qualified contractor.

Ceiling joist and rafters bowing due to inadequate Ceiling joist and rafters bowing due to inadequate support

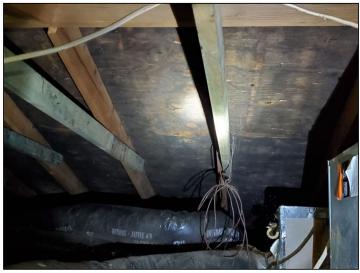
6.1. There was no ventilation installed in the attic. Recommend adding ventilation to help maintain proper humidity and temperature control.

Stains due to lack of ventilation

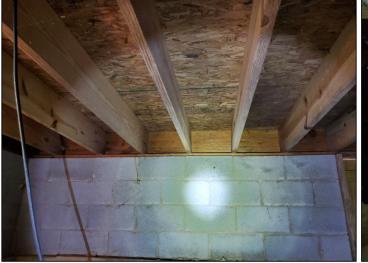
3.1. Insulation was loose or missing in areas. Recommend installing or resecuring insulation for increased energy efficiency.

Insulation loose or missing in areas

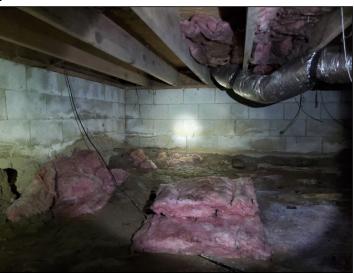
7.2. Stains and efflorescence on the interior of the foundation walls at the level of the exterior grade indicated that exterior surface runoff is seeping through the foundation wall at this level. The Inspector recommends action be taken to divert water away from the foundation exterior. See grading section for more information.

Signs of moisture intrusion at west foundation wall

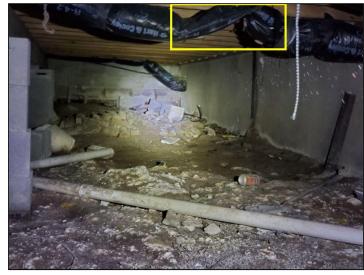
7.1. One or more supply ducts in the crawlspace were disconnected and/or damaged. Recommend repair to supply heat to the affected living space.

Damaged supply duct in crawlspace below living room
