# **INSPECTION REPORT**

Date of Inspection 12/6/2022

**Inspector: Joshua Adkins**

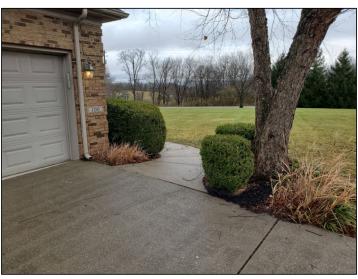
1.1. The concrete driveway and walkway had visible heaving that appeared to have been caused by tree roots. You may wish to have the tree removed to prevent the possibility of further movement of the concrete.

Tree causing concrete to heave

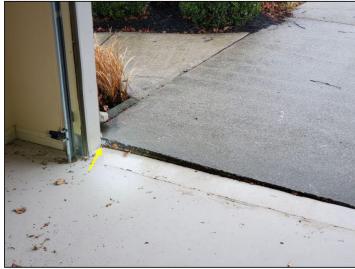
Concrete heaving

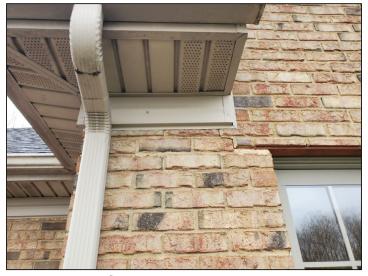
2.1. Small cracks were visible at one or more areas of the brick veneer wall cladding. Generally speaking, small cracks in the brick veneer can have numerous causes including some initial settling and are not commonly regarded as being structurally significant unless there are other problems found such as drywall cracks and/or windows/exterior doors that are difficult to open and close due to binding at the frame. Recommend sealing the cracks to prevent damage from freezing moisture and monitoring for movement.

Cracks in brick veneer

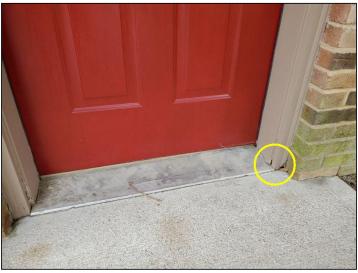
4.1. Wood deterioration observed at door trim. Recommend repairs/replacement as needed to prevent moisture intrusion from damaging the wall structure.

Wood deterioration - Door leading to basement

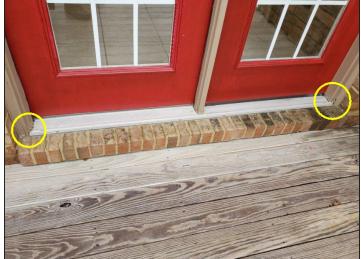
Wood deterioration - Exterior kitchen door

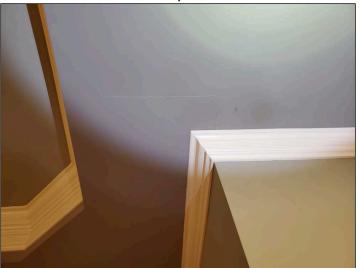
- 2.1. There were stains that appeared to be the result of moisture intrusion. The moisture meter showed no elevated levels of moisture present in the affected areas at the time of the inspection, indicating that the source of moisture may have been corrected. Recommend monitoring and asking the seller for more information.
- 2.2. Straight line cracks were noted in the ceiling finishes today. While these types of cracks can be caused by settlement they are more frequently related to routine shrinkage and seasonal expansion and contraction. No corresponding red flags were found to indicate structural problems. I recommend repairing cracks as desired and monitoring. Please note that some cracks related to expansion and contraction can be a nuisance to repair as the cracks can return after repair.

Straightline crack - Master bedroom

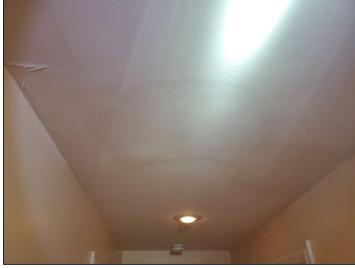
Moisture stained ceiling - Basement hallway

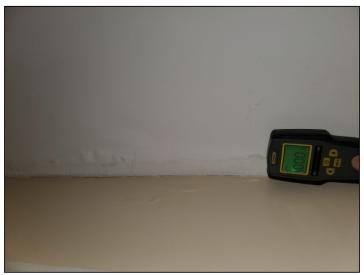
Stain tested dry - Ceiling below exterior kitchen door

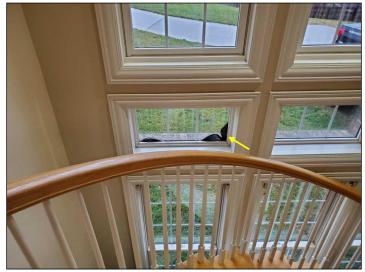
- 4.1. All of the double hung window sashes throughout the home fell when opened. This appeared to be the result of a damaged or disconnected balance spring. The sash balance spring keeps the sash from falling when opened. Recommend adjustment/repair as needed to ensure safety.
- 4.2. A window had a seal that was damaged. This condition may limit viewing out of the window due to moisture between the glass panes.

Damaged seal

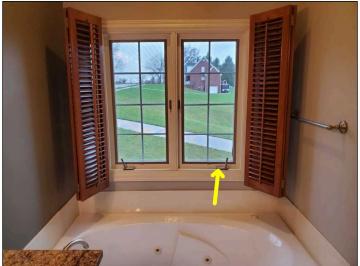
2. Walls/Ceilings	
FUNC. MON. REP. PRO. S/H	Materials: • Drywall
3. Floors	
FUNC. MON. REP. PRO. S/H	Materials: • Ceramic Tile
4. Windows	
FUNC. MON. REP. PRO. S/H	<ul><li>Materials/Type:</li><li>Wood framed, casement, double-pane window(s) noted</li></ul>
	Observations:
	4.1. A window in the master bathroom did not open when tested. Recommend evaluation and repair by a qualified person.

Window did not open
