PROPERTY LOCATION: Inspection Address City KY Zip

# **INSPECTION REPORT** PREPARED FOR: Client's Name

Date of Inspection 8/25/2020

**Inspector: Joshua Adkins**

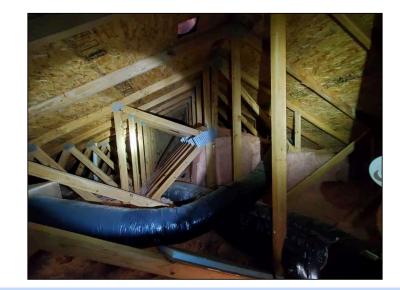
• The roof was framed using manufactured roof trusses. Manufactured roof trusses are designed by a structural engineer and prefabricated in a manufacturing facility under controlled conditions before being trucked to a homesite. Truss designs and their installation specifications are specific to individual home structures and confirming proper installation lies beyond the scope of the general Home Inspection.
