# **INSPECTION REPORT**

Date of Inspection 12/6/2022

**Inspector: Joshua Adkins**

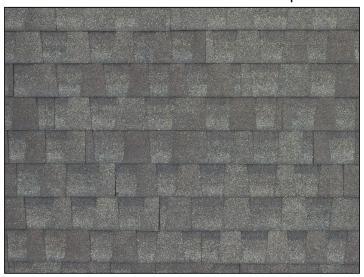
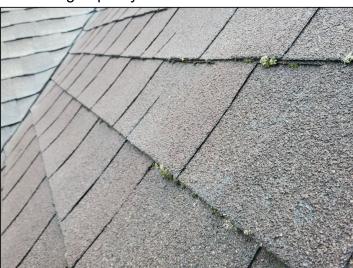
**Exterior Appearance:** The inspector observed no deficiencies in the condition of the roof structure exterior.

*Materials:* The roof was covered with dimensional asphalt shingles, also called "architectural" shingles. Dimensional shingles with multiple layers bonded together are usually more durable than shingles composed of a single layer. Dimensional shingles usually have a 30-40 year warranty. The actual useful lifespan varies with shingle quality.

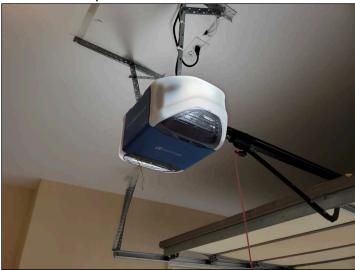
6.1. Belt drive opener noted.

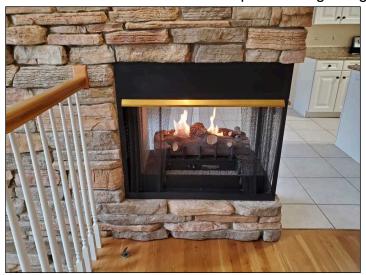
Prefabricated "zero clearance" fireplace with gas logs noted.

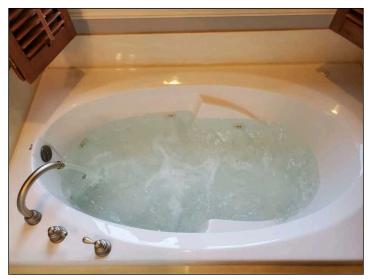
11.1. Whirlpool tub observed. Tub was filled to a level above the water jets and operated to check intake and jets. The tub was then drained to check for leaks and/or damage. Pump and supply lines were not completely visible or accessible. The items tested appeared to be in serviceable condition.

Jets tested

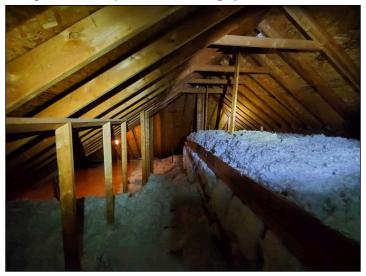
• The roof structure was built of dimensional lumber using conventional framing methods (rafters and ridge).

Conventional framed

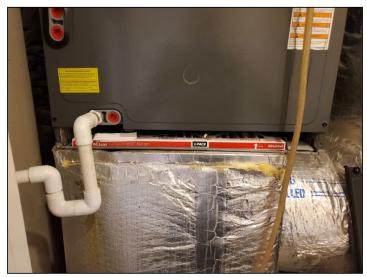
FUNC.	MON.	REP.	PRO.	S/H	. I acation.
<b>/</b>					Location: Inside air handler.

20x20x1 Filter
